**Appendix 3-E: Marsh Park, Phase II Supporting Documents**

# TAYLOR YARD: OPPORTUNITY AREA

SCA’s scope of work for this project consisted of a hazardous materials survey of the interiors and exteriors of both buildings (including the accessible portions of the roofs), prior to their demolition.

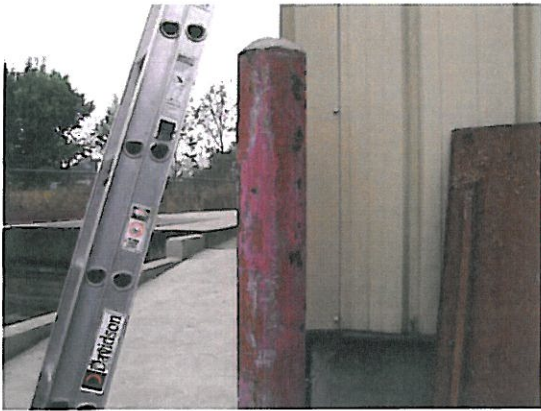
1. Lead-based chipped red paint on the exterior steel bollard at the Warehouse [Bulk Sample I.D. Pb-06-RD, containing 11,000 ppm].

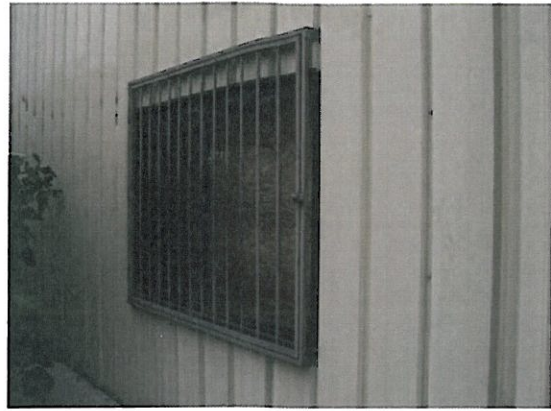
2. Lead-containing chipped gray paint on exterior window frames of the Warehouse [Bulk Sample I.D. Pb-07-GY, containing 1,600 ppm].

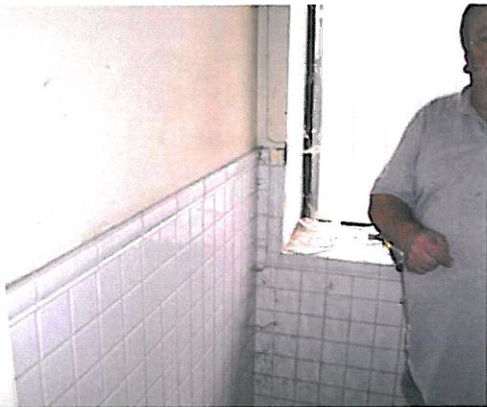
3. Lead-glazed ceramic wall and floor tiles, present in the Men's and Women's Restrooms (Assumed lead-glazed by SCA).

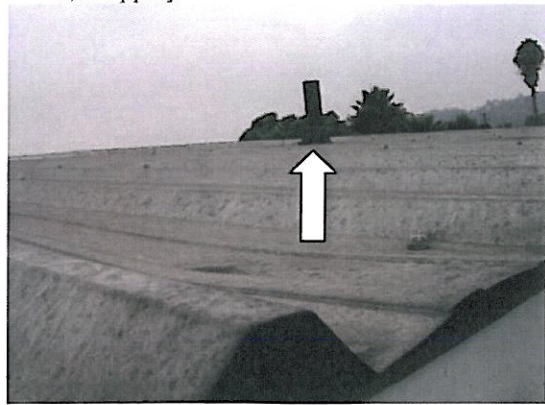
4. ACM roof penetration mastic associated with the restroom vent penetration, totaling about 3 square feet (Assumed asbestos-containing by SCA).

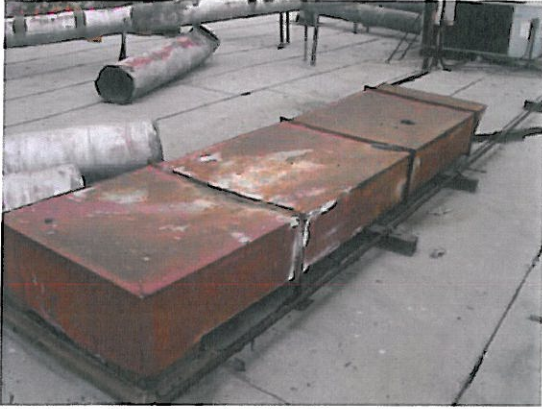
1. Intact lead-based red paint on metal HVAC equipment housing and ductwork on the Roof of the Factory [Bulk Sample I.D. Pb-08-RD, containing 21,000 ppm].

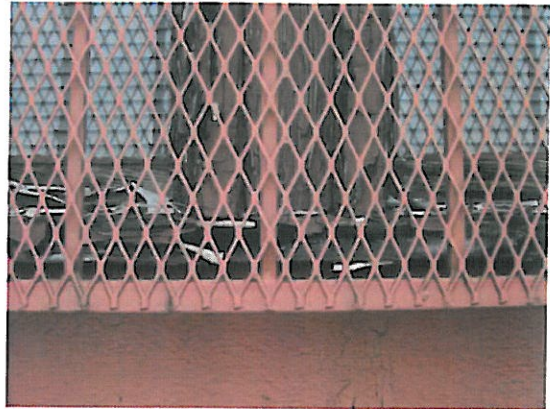
2. Severely chipped and peeling lead-based red paint on the exterior wood window frames of the Factory [Bulk Sample I.D. Pb-11-RD, containing 67,000 ppm].

Loose and peeling paints and glazed ceramic tiles should be removed under controlled procedures, prior to demolition. None of the applicable regulations require removal of LBP prior to demolition, if the paints are securely adhered to the substrates (i.e., non-flaking or non-peeling). Disposal requirements for the debris in this case shall be determined by the results of the waste characterization process.

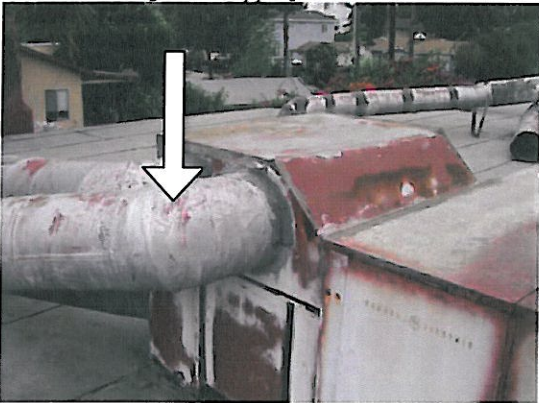
3. Peeling lead-containing silver paint (also ACM) on the roof-mounted HVAC unit housing and ductwork of the Factory [Bulk Sample I.D. Pb-09-SLVR, containing 900 ppm].

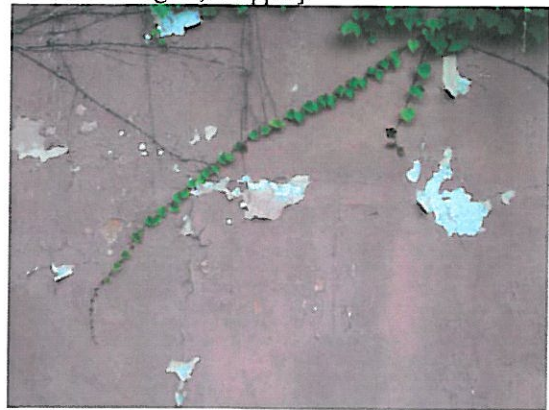
4. Chipped and peeling lead-containing red paint on the exterior stucco walls of the Factory [Bulk Sample I.D. Pb-10-RD, containing 900 ppm].

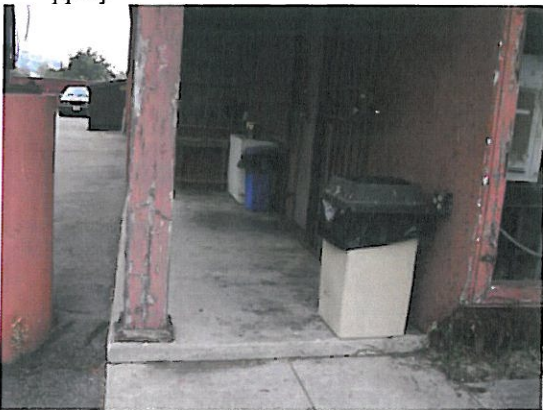
5. Chipped and peeling lead-based brown paint on an exterior wood support column and wood utility housing of the Factory [Bulk Sample I.D. Pb-14-BR, containing 38,000 ppm].

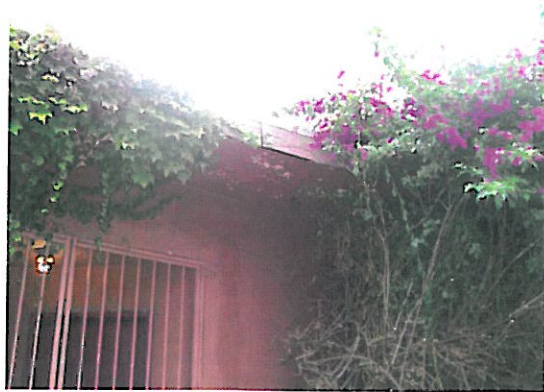
6. Severely chipped and peeling lead-based red paint on the exterior wood fascia of the Factory [Bulk Sample I.D. Pb-19-RD, containing 22,000 ppm].

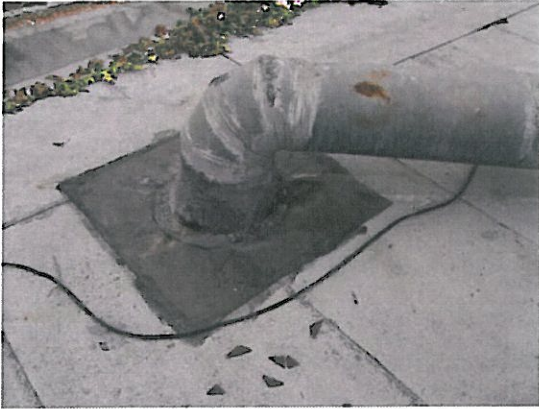
7. ACM black mastic associated with roof penetrations, totaling about 50 ft<sup>2</sup> [Sample I.D. RFMAS-05-01, -02, -03, containing 4% Chrysotile asbestos (CH)].

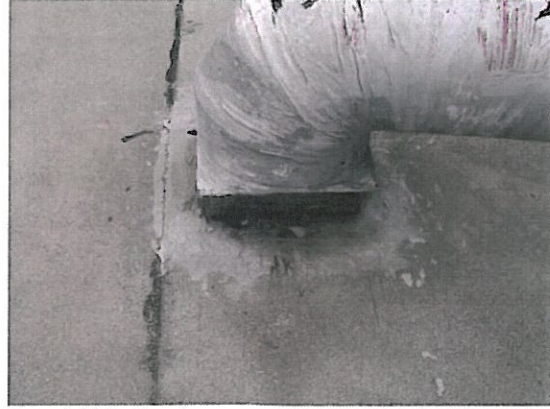
8. ACM silver/gray mastic associated with roof penetrations, totaling about 100 ft<sup>2</sup> [Sample I.D. RFMAS-06-01, -02, -03, containing 3% CH].

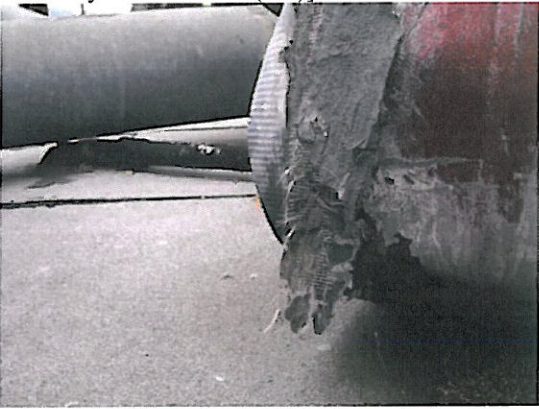
9. ACM HVAC duct tape and mastic (canvas type, with gray coating), totaling about 75 ft<sup>2</sup> [Sample I.D. HDUTP-07-01, -02, -03, containing 5% CH].

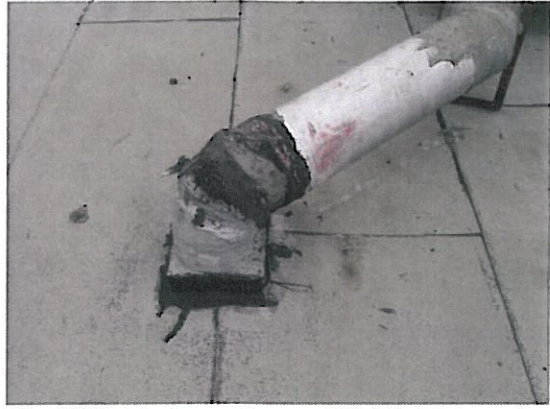
10. ACM black mastic on HVAC joints and seams, totaling about 20 ft<sup>2</sup> [Sample I.D. HMAS-09-01, -02, -03, containing 2% CH].

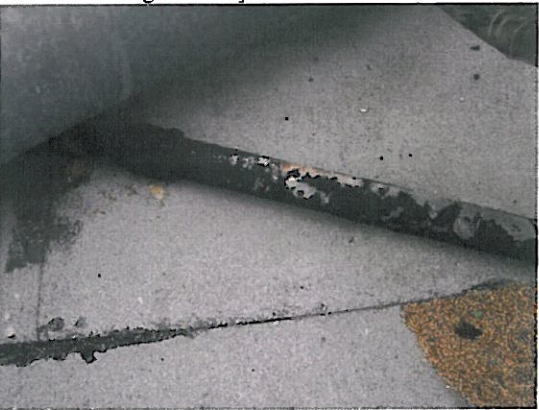
11. ACM black, tarry wrap/coating on 1” and 2” pipes on the roof, totaling about 30 ft<sup>2</sup> [Sample I.D. MISC-10-01, -02, -03, containing 3% CH].

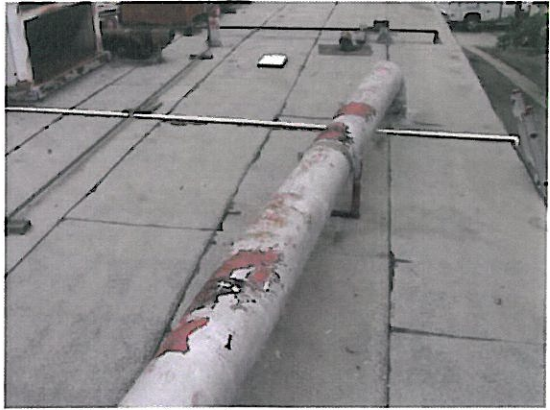
12. ACM and lead-containing silver texture coating on “round” HVAC ductwork, totaling about 400 ft<sup>2</sup> [Sample I.D. MISC-11-01, -02, -03, containing 3% CH].

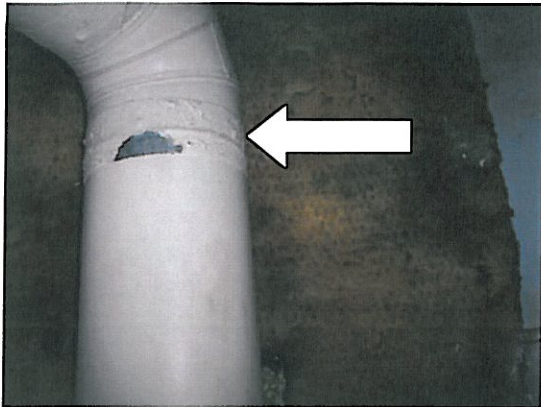
13. ACM white, painted HVAC duct seam tape on a duct associated with the heater in the Women’s Restroom closet, totaling about 3 ft<sup>2</sup> [Sample I.D. HDUCTP-16-01, containing 70% CH].

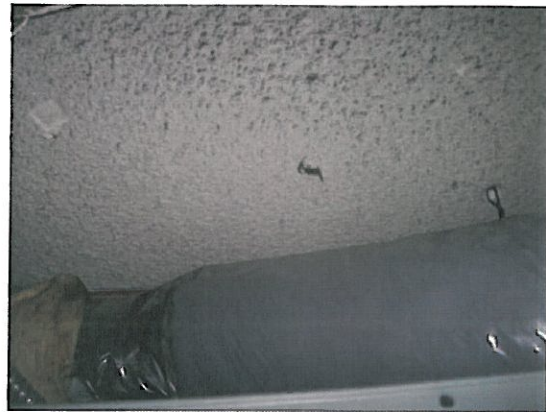
14. ACM sprayed-on acoustical ceiling finish, totaling about 1,000 ft<sup>2</sup> (occurring above non-ACM laid-in ceiling tiles) [Sample I.D. CLTX-17-01, -02, -03, containing 5% CH].

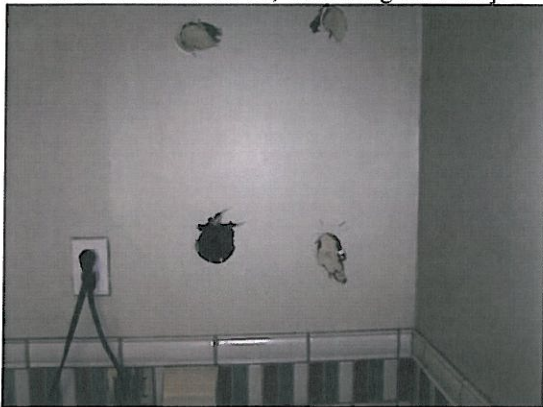
- Black mirror mastic on a wall (mirror was missing), totaling about 1 ft<sup>2</sup> in the Men’s Restroom [Sample I.D. MASTIC-19-01, containing 10% CH].

15. ACM black mirror mastic on a wall (mirror absent), totaling about 1 ft<sup>2</sup> in the Men’s Restroom [Sample I.D. MASTIC-19-01, containing 10% CH].

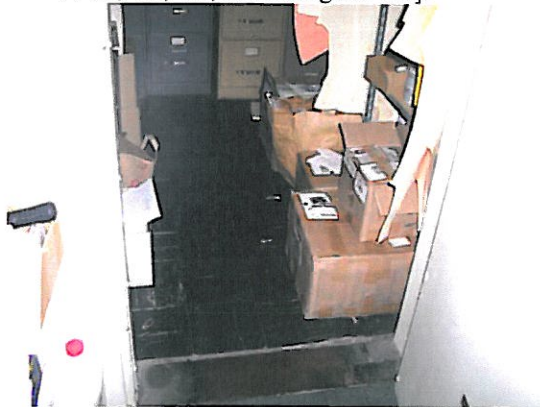
- 9" x 9" black vinyl floor tiles with tan streaks, and associated black mastic (typically concealed beneath carpet), totaling about 2,400 ft<sup>2</sup> [Sample I.D. FLVCT-23-01 through -03, containing >1% CH in the tiles and 2% CH in the mastic].
- ACM black mastic beneath non-ACM leveling compound (and under residual non-ACM yellow mastic) in the Office Storage Room, totaling about 10 ft<sup>2</sup> [Sample I.D. MISC-24-01 through -03, containing 3% CH].
- Residual brown wall mastic (including potentially concealed material) observed in the Storage Room, Sewing Room and Men's Restroom, totaling about 25 ft<sup>2</sup> of un-concealed material [Sample I.D. MASTIC-27-01 through -03, containing 1-2% CH].
- Concealed wall mastic (assumed present behind wood and cork wall panels), totaling about 500 ft<sup>2</sup> of concealed material [I.D. MASTIC-AAA, assumed ACM >1%].

16. ACM 9” x 9” black vinyl floor tiles with tan streaks and associated black mastic (typically concealed beneath carpet), totaling about 2,400 ft<sup>2</sup> [Sample I.D. FLVCT-23-01, -02, -03, containing >1% CH in the tiles, 3% CH in the mastic].

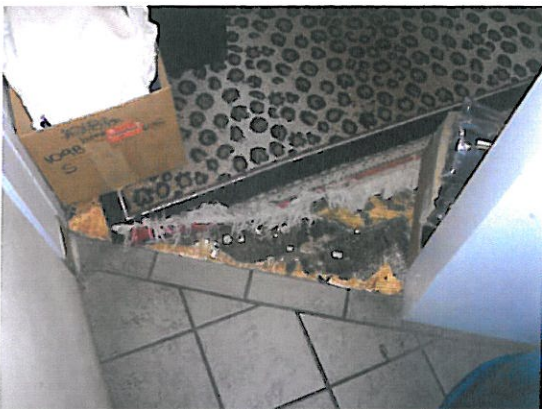
17. ACM black mastic present below non-ACM leveling compound in the Office Storage Room, totaling about 10 ft<sup>2</sup> [Sample I.D. MISC-24-01, -02, -03, containing 3% CH in the mastic, only].

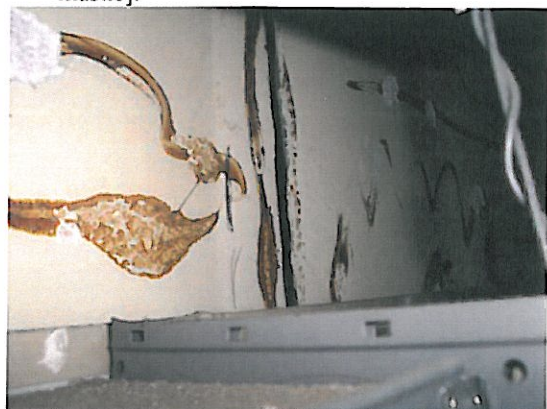
18. ACM brown wall mastic (including concealed material) observed in a Storage Room, Sewing Room and Men’s Restroom, totaling about 25 ft<sup>2</sup> observed [Sample I.D. MASTIC-27-01, -02, -03, containing 1-2% CH].

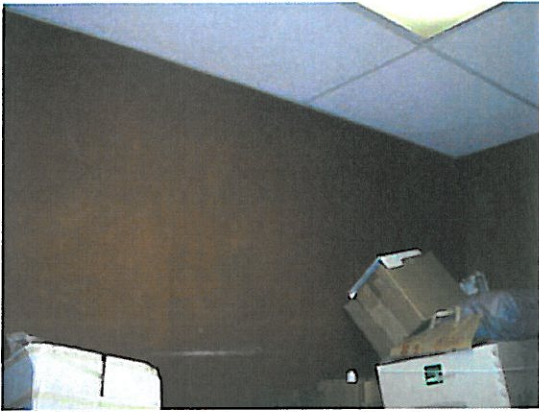
19. ACM concealed wall mastic (assumed present behind wood and cork wall panels), totaling about 500 ft<sup>2</sup> [I.D. MASTIC-AAA, assumed asbestos containing by SCA].

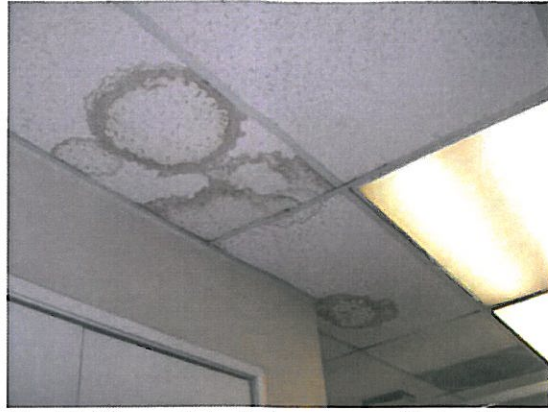
Considerable water damage was observed in the “Factory” building as evidenced by water stains on ceilings, and damaged substrates, although visible mold growth was not observed by SCA at the time of the survey. It is possible that concealed mold growth may be present in some areas. Mold and fungi are potential bio-hazards to workers. These hazards should be abated in conjunction with demolition, by trained workers in respirators and other personal protective equipment, such as gloves and Tyvek<sup>®</sup>-type protective suits.

20. Visible water stains on ceiling tiles, attributed to roof leaks.

Water infiltration and associated substrate damage was evident in throughout the "Factory" building (only). The water damage, which SCA attributes to roof leaks (including around HVAC duct penetrations) is a source for potential mold growth. Any mold growth (none was observed by SCA at the time of the survey) should be addressed in conjunction with the demolition of the "Factory" building.
