**Appendix 3-E: Marsh Park, Phase II Supporting Documents**

# TAYLOR YARD: OPPORTUNITY AREA

SCA’s scope of work for this project consisted of a hazardous materials survey of the interiors and exteriors of both buildings (including the accessible portions of the roofs), prior to their demolition.

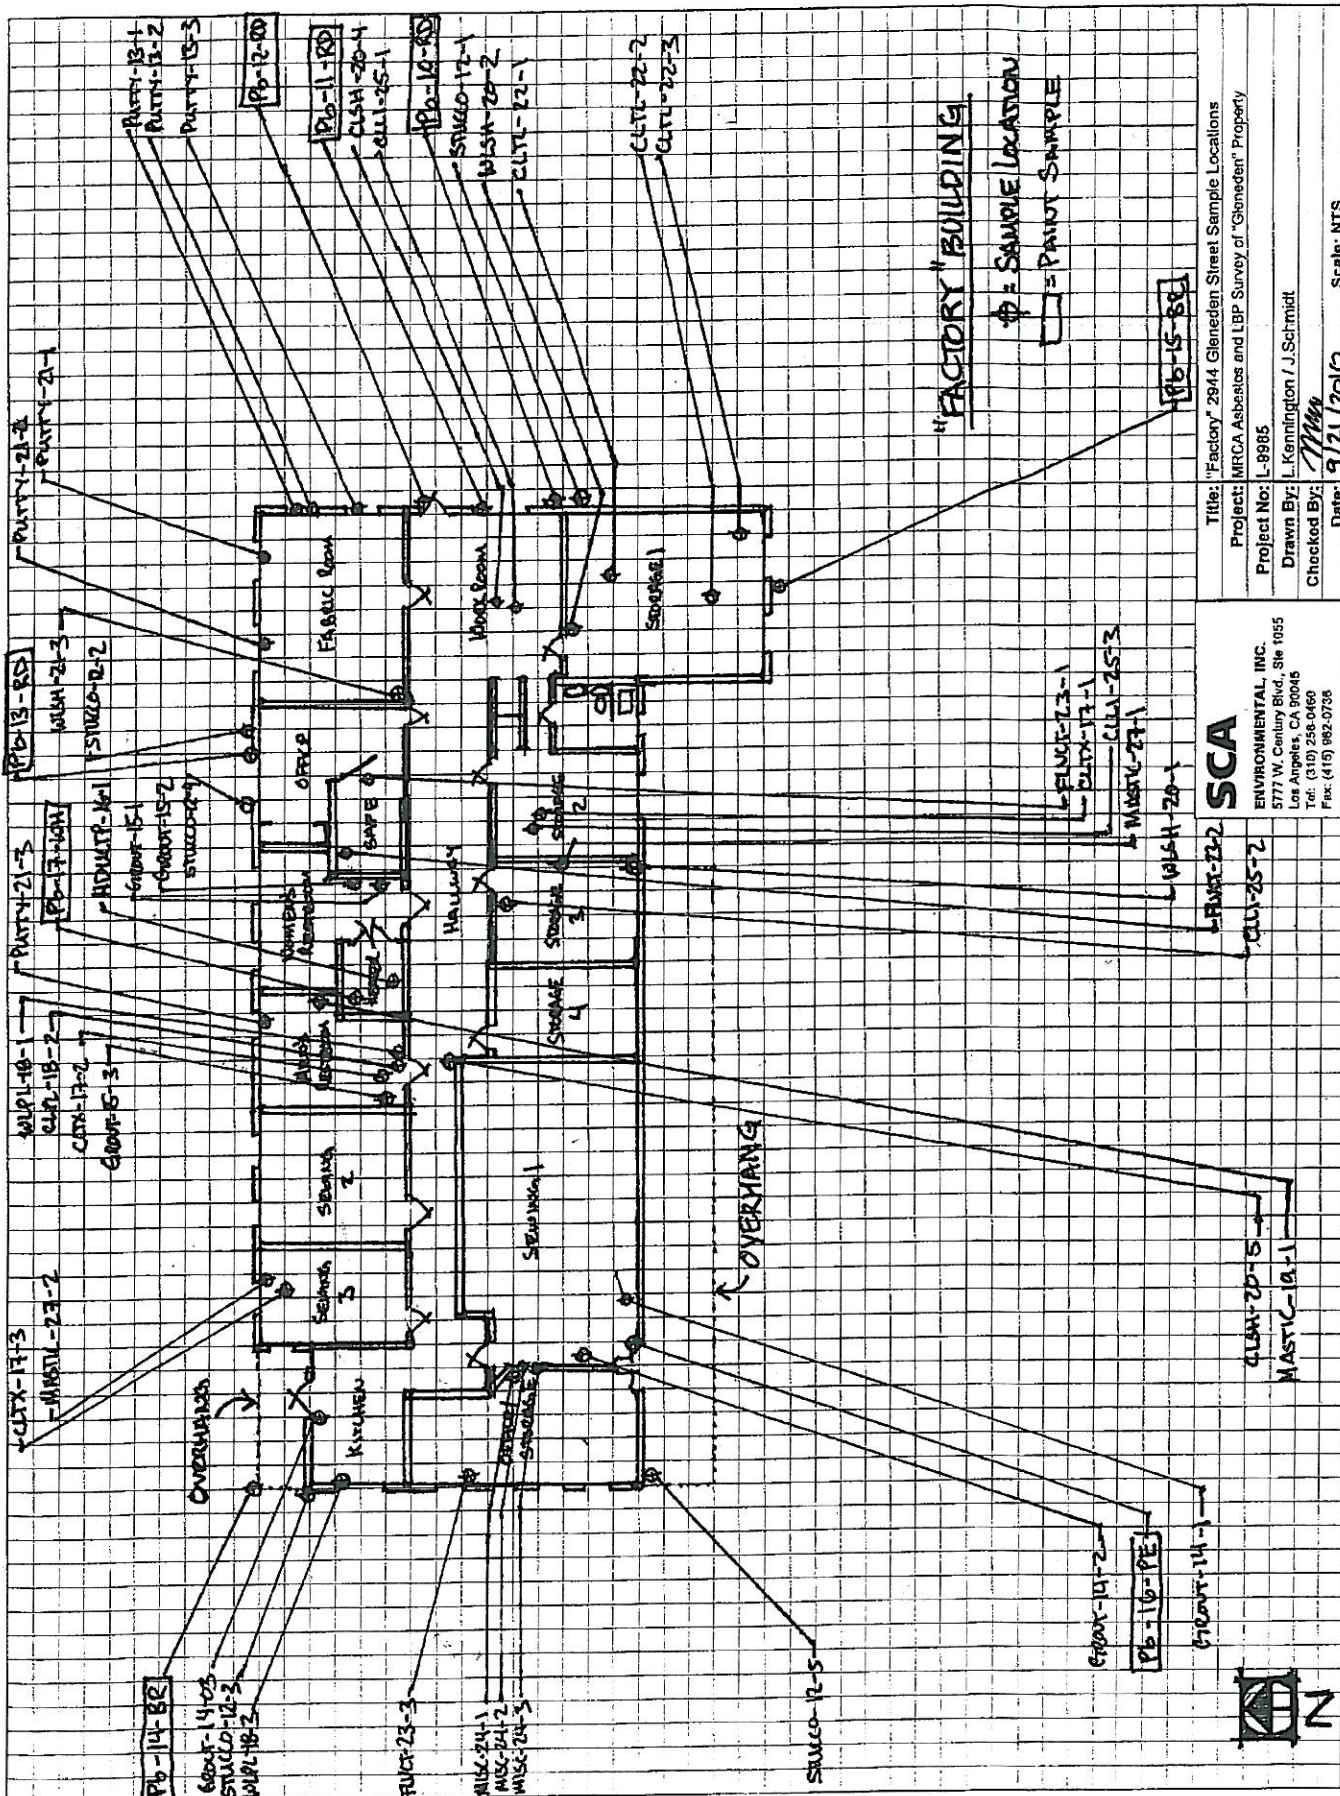
Title: "Factory" 2944 Glendelen Street Sample Locations  
 Project: MRCA Asbestos and LBP Survey of "Glendelen" Property  
 Project No: L-8985  
 Drawn By: L. Kemington / J. Schmidt  
 Checked By: *MM*  
 Date: 9/21/2010 Scale: NTS

**"FACTORY" BUILDING**  
 ○ = SAMPLE LOCATION  
 □ = PAINT SAMPLE

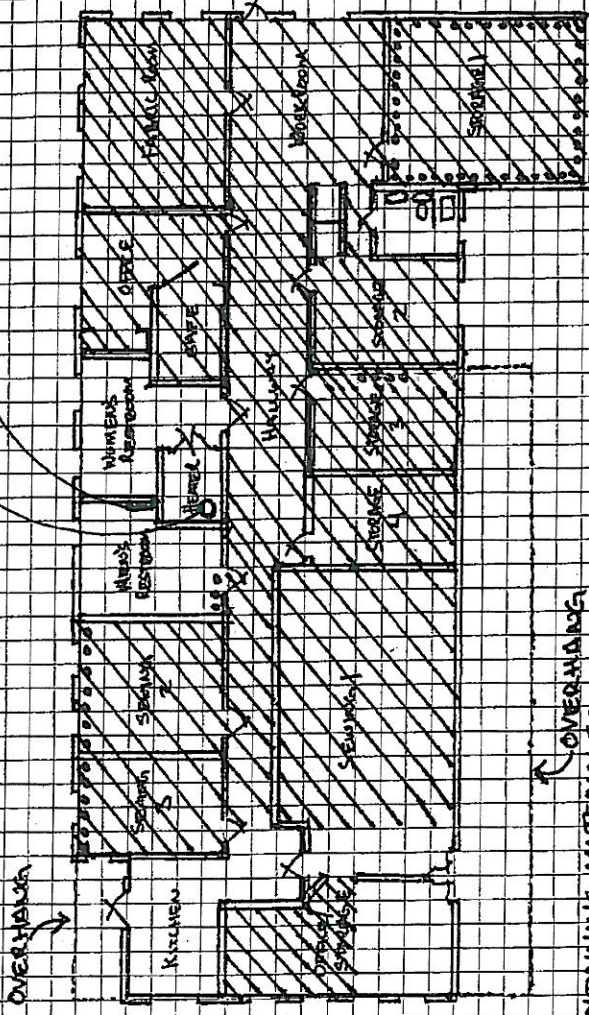
"FACTORY"

DUCT-16 (ACM)  
MASTIC-14 (ACM)

- FLUCT-23: BLACK WITH TAN STRAINS BUILT FLOOR TILES AND ASSOCIATED BLACK MASTIC (PRIMAVERIALLY CONCEALED BEHIND CARPET) - ACM FLOOR TILE AND MASTIC.
- DUCT-16: WHITE PAINTED FIBROUS DUCT SEAM TAPE ON HEATER IN THE CLOSET - ACM
- MASTIC-14: BLACK MORTAR POLYMER MASTIC (MAYBE ABSENT)
- MASTIC-27: RESIDUAL BROWN WALL MASTIC, ACM AND ASSUMED - ACM POTENTIALLY CONCEALED BEHIND CERAMIC BEHIND CORK AND WOOD WALL PANELS - ACM MASTIC SAMPLED

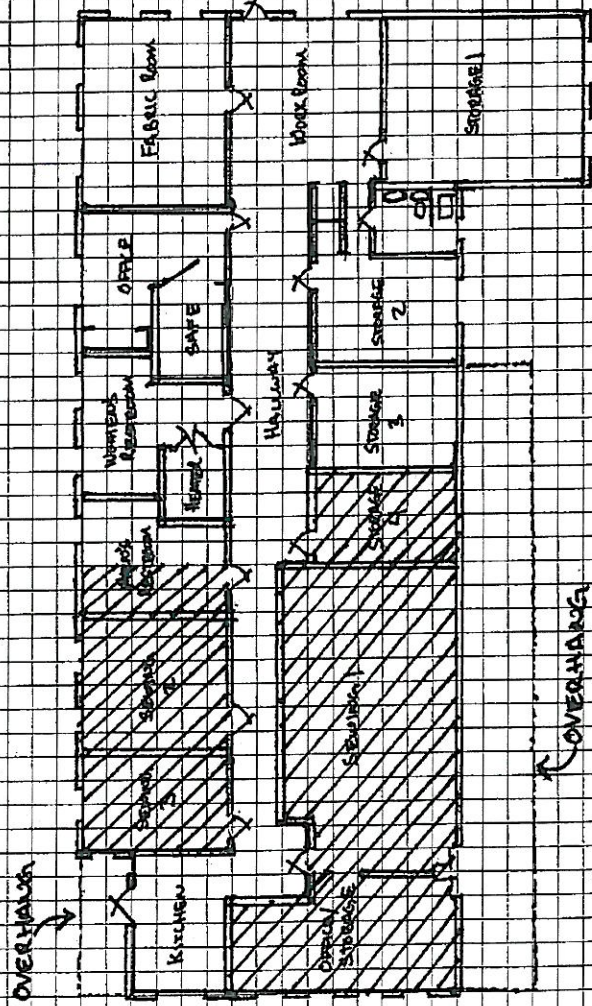
ASBESTOS CONTAINING MATERIALS:  
 = CLTX-IT: SPANED ACoustICAL CEILING PLASTER.  
 (ACLM)

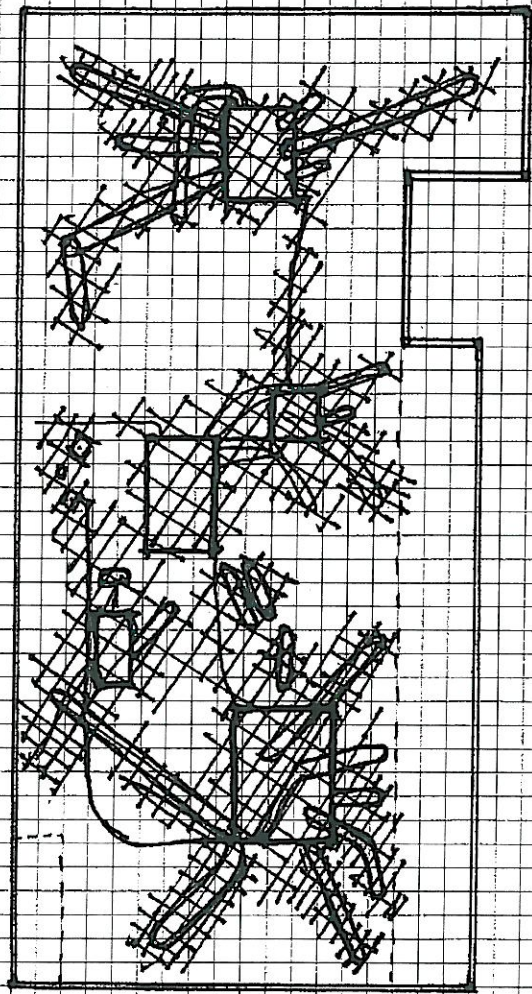
- ACM ROOFING MASTICS ASSOCIATED WITH HVAC DUCTS, JOINTS, SEAMS & PENETRATIONS:
- RFMS-05: BLACK MASTIC ASSOCIATED WITH ROOF PENETRATIONS
- RFMS-06: SILVER/GRAY MASTIC ASSOCIATED WITH ROOF PENETRATIONS
- HDTP-07: HVAC DUCT TAPE AND MASTIC (CONTAINS TYPE 1044 GRAY CONTAIN.)
- HMS-09: BLACK MASTIC ON HVAC JOINTS AND SEAMS
- MISC-10: BLACK TARRY MASTIC/CONTAIN ON 1" AND 2" PIPES ON THE ROOF
- MISC-11: SILVER TARRANT COATING ON "ROUND" HVAC DUCTWORK
